HUNT LAKE DAM
SHANNON COUNTY, MISSOURI
MISSOURI INVENTORY NO. 31076

6 PHASE I INSPECTION REPORT
NATIONAL DAM SAFETY PROGRAM.

Name of Dam:	Hunt Lake Dam
State Located:	Missouri
County Located:	Shannon County
Stream:	Tributary of Pike Creek
Date of Inspection:	24 August 1979

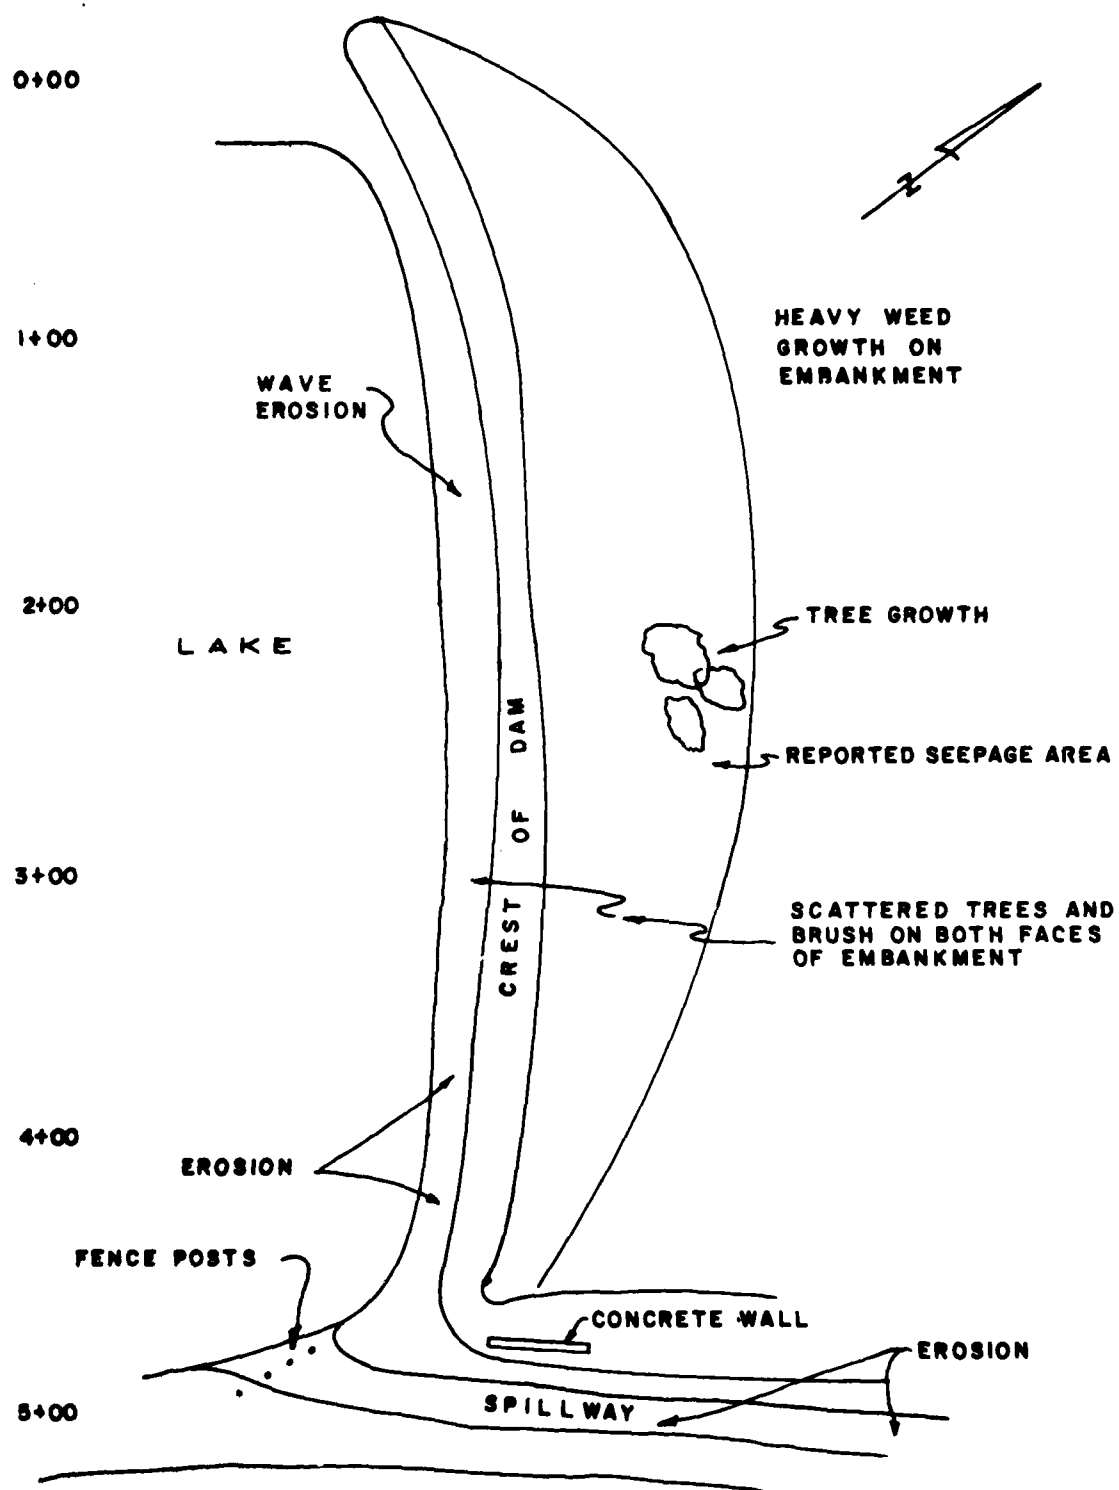
PLAN SKETCH
INSPECTION OBSERVATION
DAM No. MO. 31076

The embankment of the dam appears to be in generally good condition. No sloughing or obvious seepage through the embankment was observed. Seepage has been reported when the lake is at or above normal pool. This area was believed to be near the toe of the embankment near the mid point of the dam. On the date of inspection, the lake level was about 2.5 ft. below normal pool, and no evidence of seepage was noticed. The dam was constructed with a gentle curve which is concave to the downstream direction. The dam is fairly level across the crest, and no surface cracking or unusual movement was noted. Shallow auger probes into the embankment indicated the top portion of the embankment to consist of fine to coarse sand, pebbles and cobbles in a brown fine sandy silty clay matrix. There was no noticeable serious erosion on the embankment. Some minor erosion was noted on the upstream face of the embankment near the east abutment. No erosion protection was provided on the front face.

The primary spillway is an earth swale located in the east abutment. The approach to the spillway is relatively clear; however, several old fence posts are across the entrance. No non-erodible control section is provided for the protection of the spillway. Significant erosional damage has occurred in the outlet channel. A berm separates the discharge channel from the dam and discharges would not be expected to damage the embankment. The berm could however erode out with time if the channel is not maintained.

- (1) Seepage and stability analyses comparable to the requirements of the recommended guidelines should be performed by an engineer experienced in the design and construction of dams.
- (2) Brush and tree growth should be removed from the dam and spillway channel.
- (3) Erosional areas on the front face of the embankment and in the spillway discharge channel should be repaired and maintained.
- (4) The purported seepage area through the embankment should be investigated and evaluated when the reservoir is at or above normal pool elevation by a professional engineer experienced in the design and construction of dams.

- (5) Non-erodible control sections should be provided for the spillway so that progressive erosion of the spillway will not lower the normal pool of the reservoir.
- (6) Protection from wave erosion should be provided for the upstream face of the embankment.
- (7) Fence posts at the entrance to the primary spillway should be removed.
- (8) A detailed inspection of the dam should be made periodically by an engineer experienced in the design and construction of dams.
